Manhole Inspection Summary

Manhole # S13YY1017MH

Location Address: **2308 SOUTH RD** Cross Street: **GREENSPRING AVE**

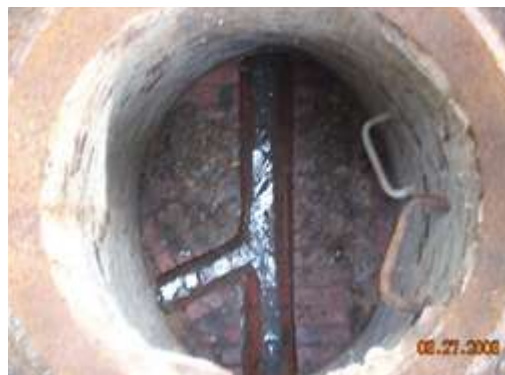
Top View

Bench ☒ Exists Material: **Brick** ☐ Parged ☒ **Debris** (not Condition related)
Condition: ☒ Sound ☐ Cracked ☐ Root Intrusion ☐ Deteriorated ☐ Leaks ☐ Debris

Steps Count: **2** Missing: **0** ☒ **Corroded**

Surcharge ☒ **Evidence Of Surcharge** Depth: **1** (ft.) ☐ Active Surcharge Present

Corroded steps. Evidence of surcharge - Bench debris.

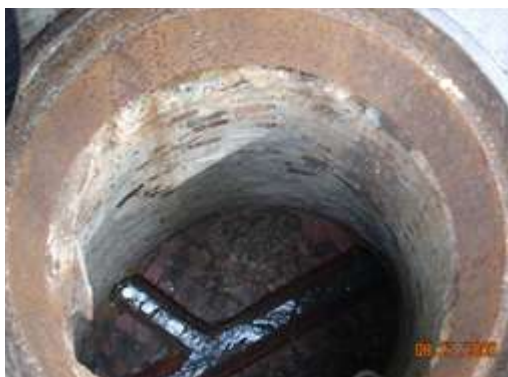
Defect

Frame Offset: **0** (in.) Condition: ☐ Sound ☐ Cracked ☒ **Leaks**

Chimney / Frame Adjustment ☒ Exists Material: **Brick** ☐ Parged Height: **6** (in.)
Condition: ☐ Sound ☐ Cracked ☐ Root Intrusion ☒ **Loose Brick** ☒ **Deteriorated**
Infiltration: ☐ None ☒ **Joint** ☐ Cracks ☒ **Mortar** ☐ Roots ☐ Wall

Frame leaks. Adjustment deterioration, loose brick and infiltration. Corbel and Barrel infiltration - other side.

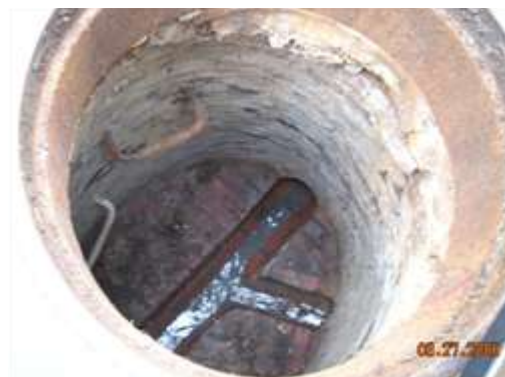
Defect

Corbel Material: **Brick** ☐ Parged Type: **Concentric/Eccentric**
Condition: ☒ Sound ☐ Cracked ☐ Root Intrusion ☐ Loose Brick ☐ Deteriorated
Infiltration: ☐ None ☐ Joint ☐ Cracks ☐ Mortar ☐ Roots ☒ **Wall**

Barrel Material: **Brick** ☐ Parged
Shape: **Circular** Diameter: **48** (in.) Length: (in.)
Condition: ☒ Sound ☐ Cracked ☐ Root Intrusion ☐ Loose Brick ☐ Deteriorated
Infiltration: ☐ None ☐ Joint ☐ Cracks ☐ Mortar ☐ Roots ☒ **Wall**

Frame leaks. Adjustment deterioration, loose brick and infiltration. Corbel and Barrel infiltration.

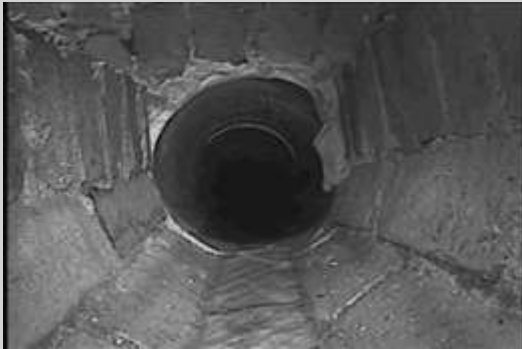
8 in. Circular Gravity Sewer Pipe Out @ 12 O'Clock

Infiltration: **Evidence** Pipe Seal Cond: **Unknown**

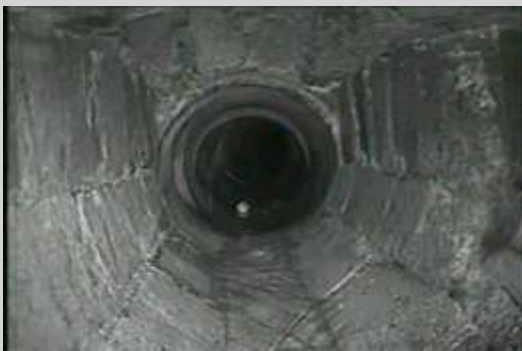
8 in. Circular Gravity Sewer Pipe In @ 6 O'Clock

Infiltration: **Evidence** Pipe Seal Cond: **Unknown**

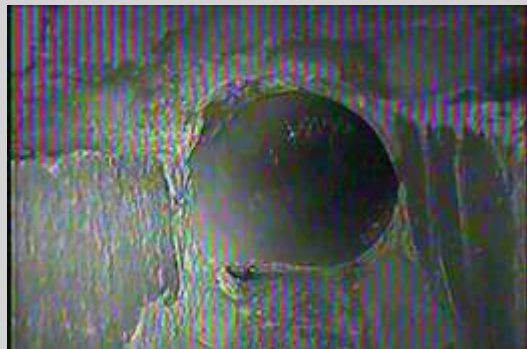
Pipe In @ 8 O'Clock

Infiltration: **Evidence**

Pipe Seal Cond: **Cracked**
